**This project update covers the period  
of April 2025**

## Cyclops restoration programme April 2025

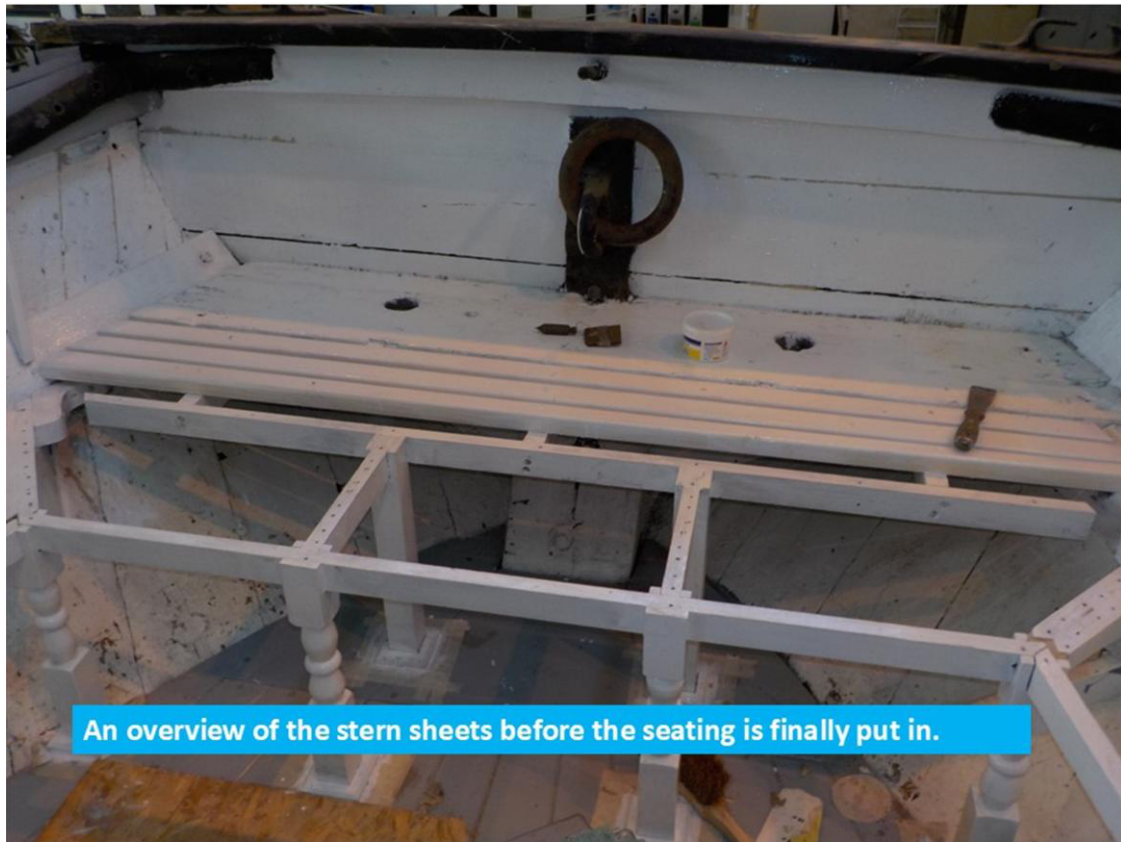
An overview of the stern sheets before the seating is finally put in.

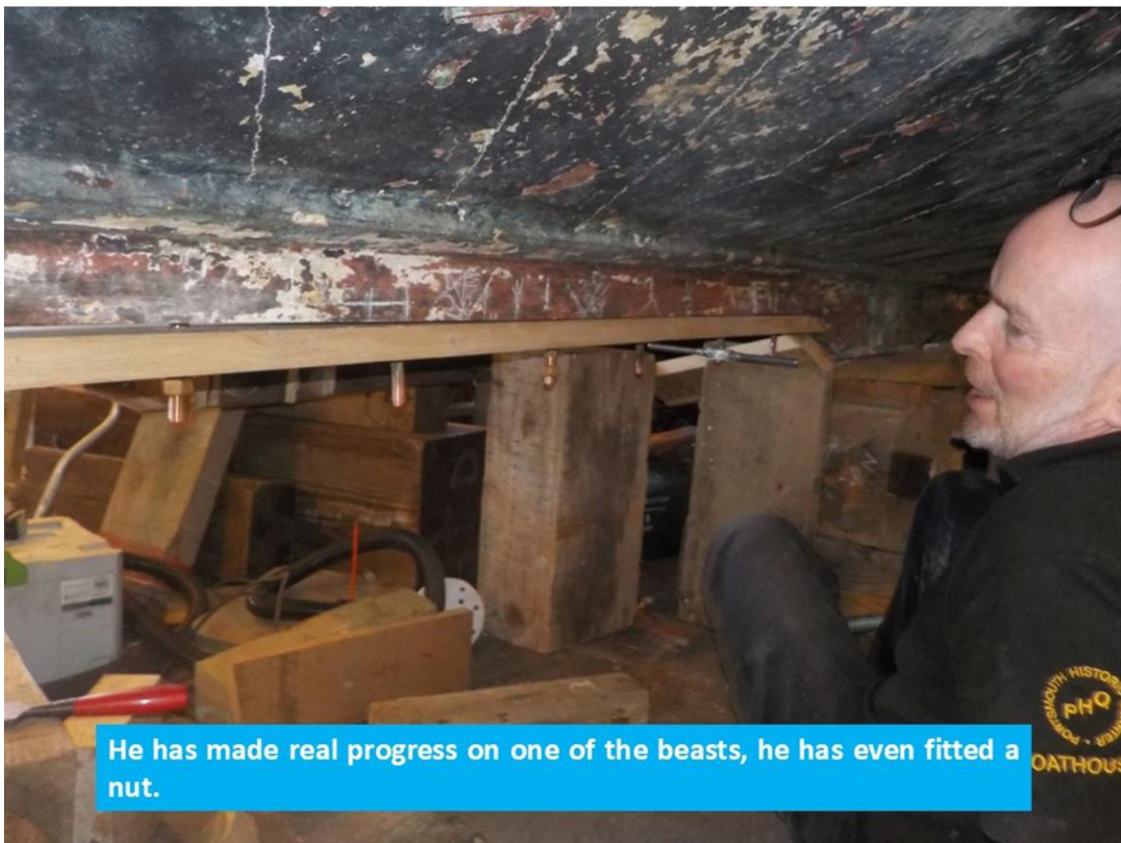
He has made real progress on one of the beasts, he has even fitted a nut.

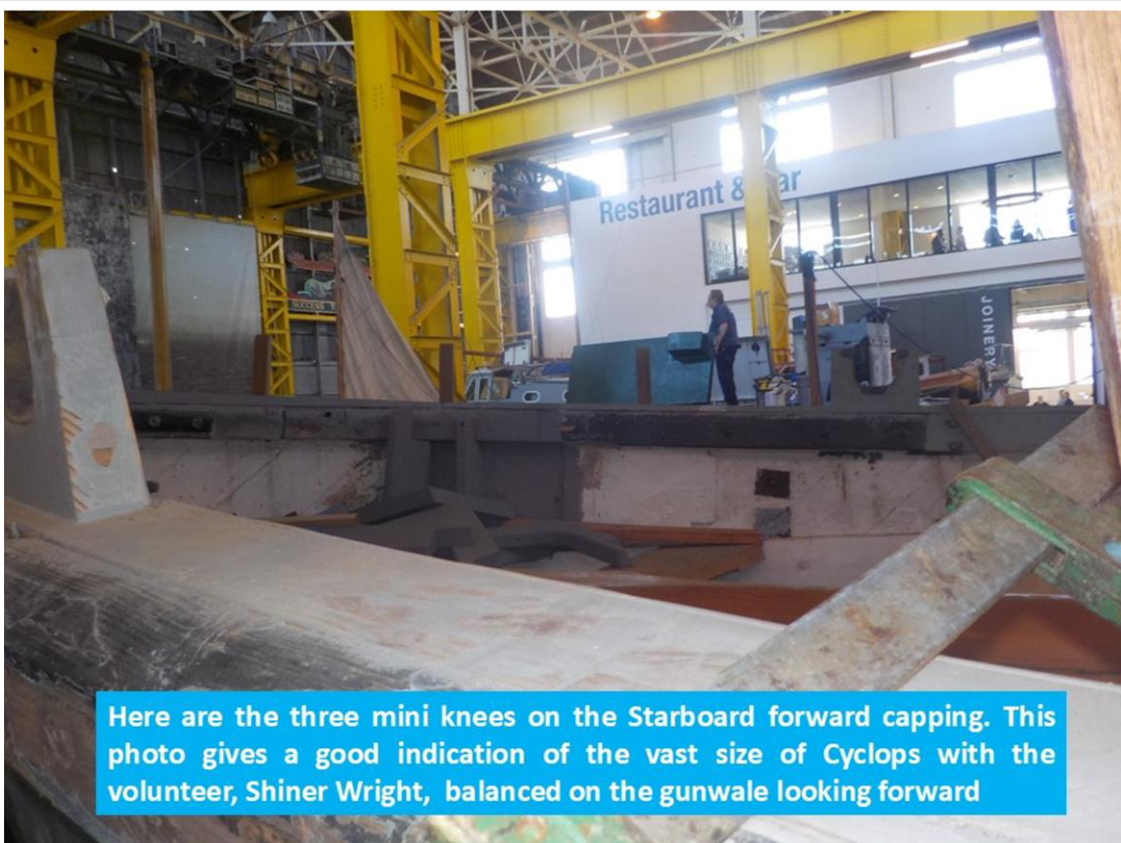
Here are the three mini knees on the Starboard forward capping. This photo gives a good indication of the vast size of Cyclops with the volunteer, Shiner Wright, balanced on the gunwale looking forward

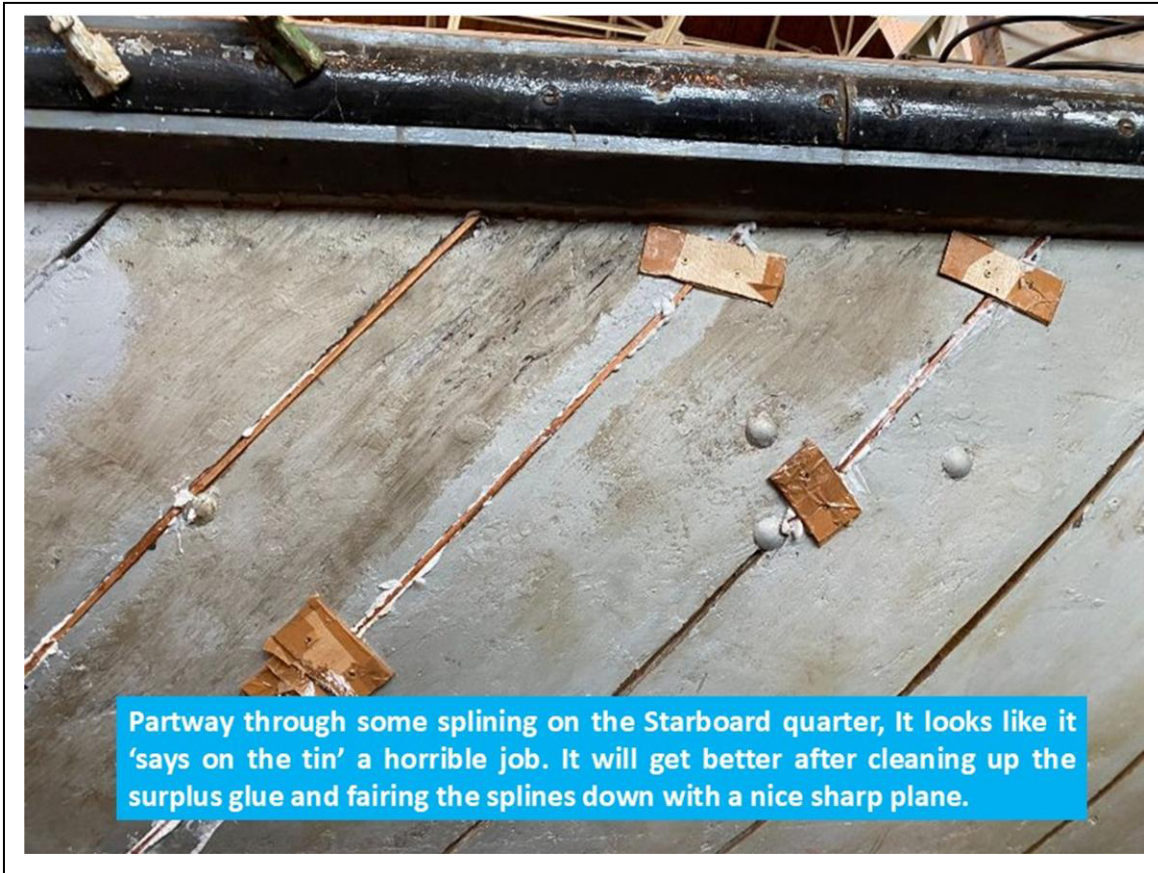
Partway through some splining on the Starboard quarter, It looks like it 'says on the tin' a horrible job. It will get better after cleaning up the surplus glue and fairing the splines down with a nice sharp plane.

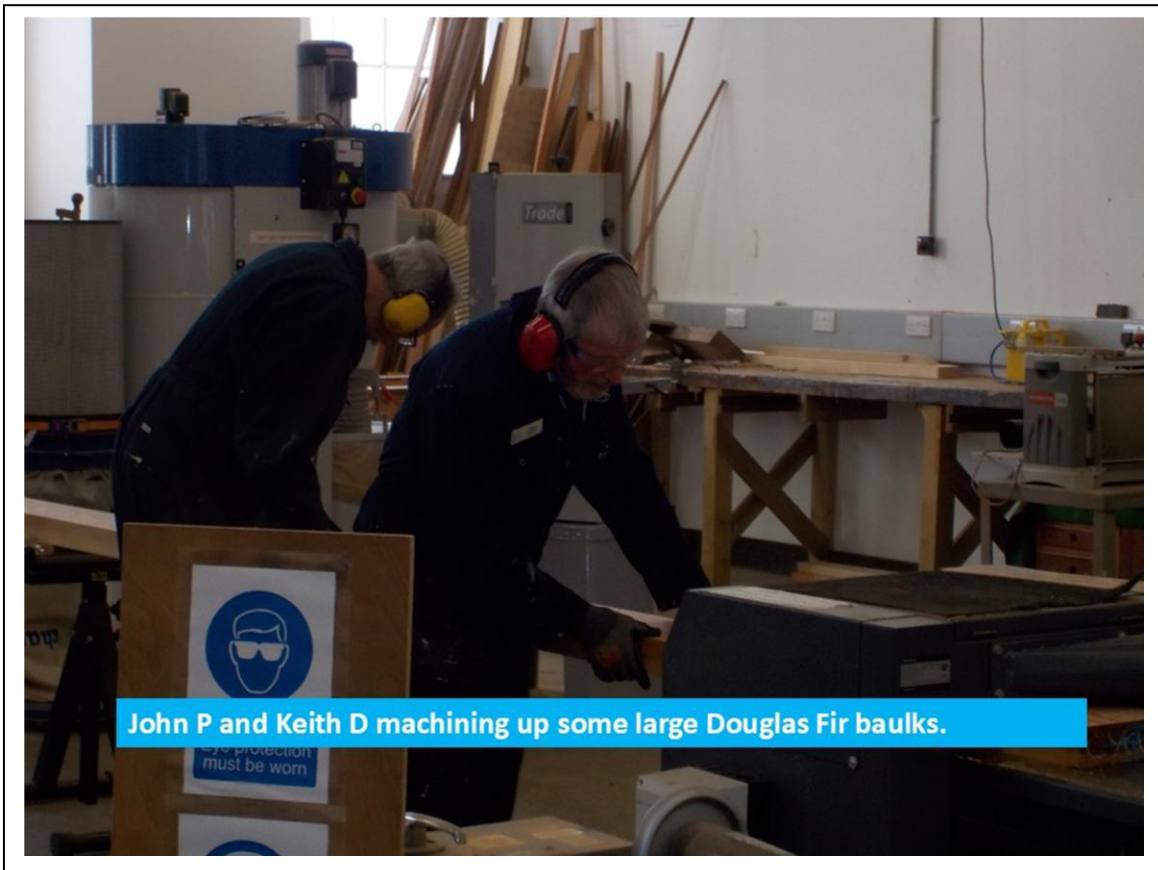
John P and Keith D machining up some large Douglas Fir baulks.

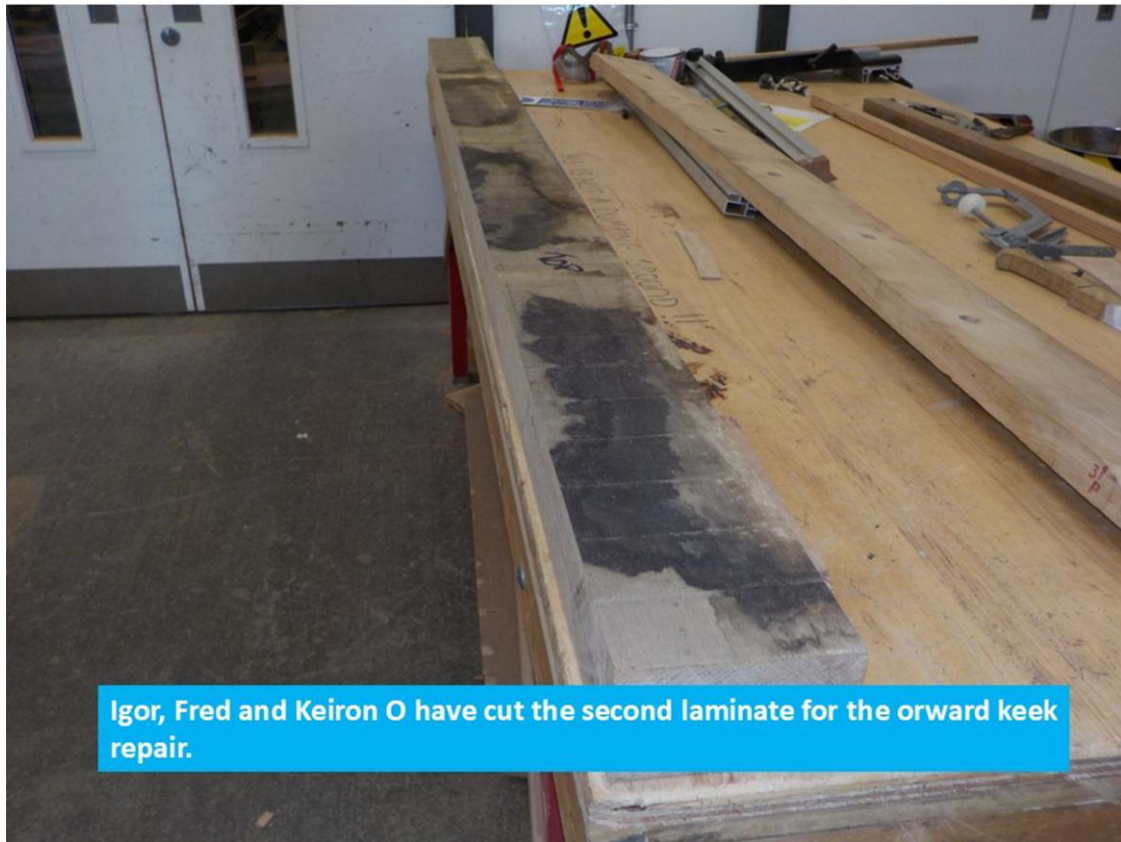
Igor, Fred and Keiron O have cut the second laminate for the orward keek repair.

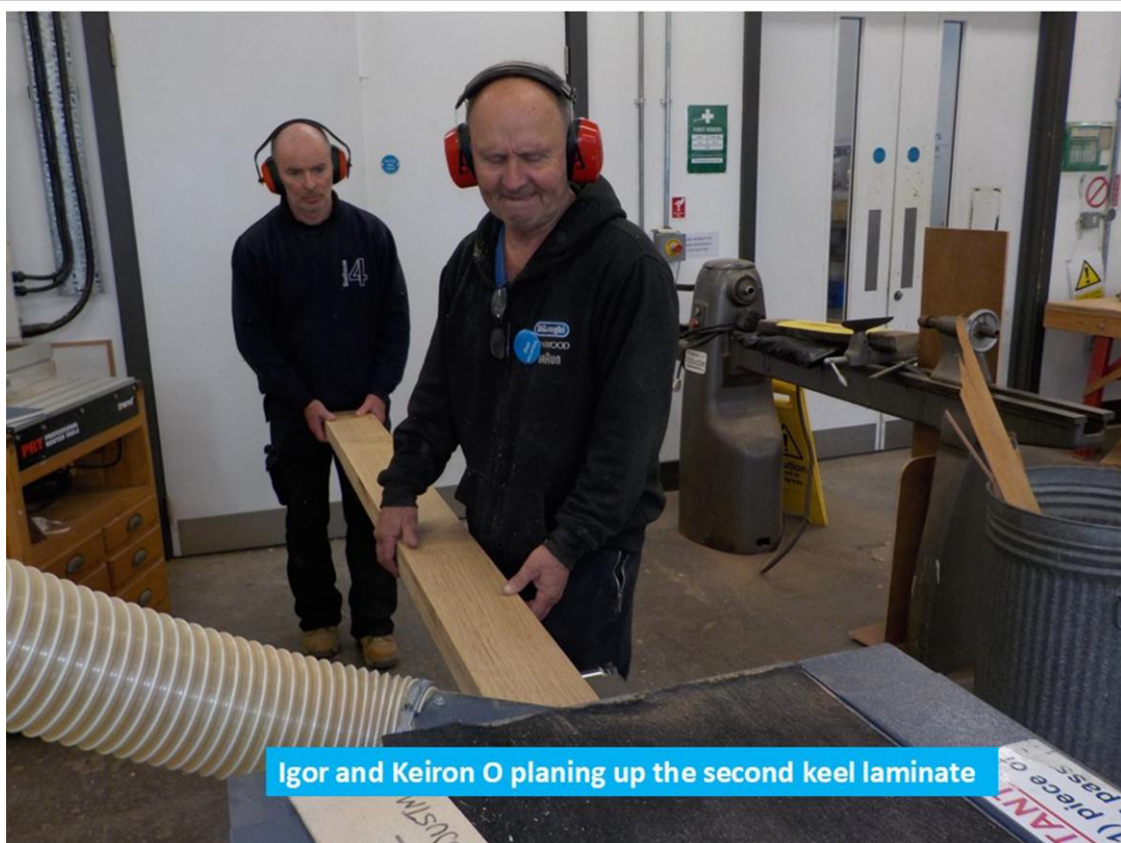
Igor and Keiron O planing up the second keel laminate

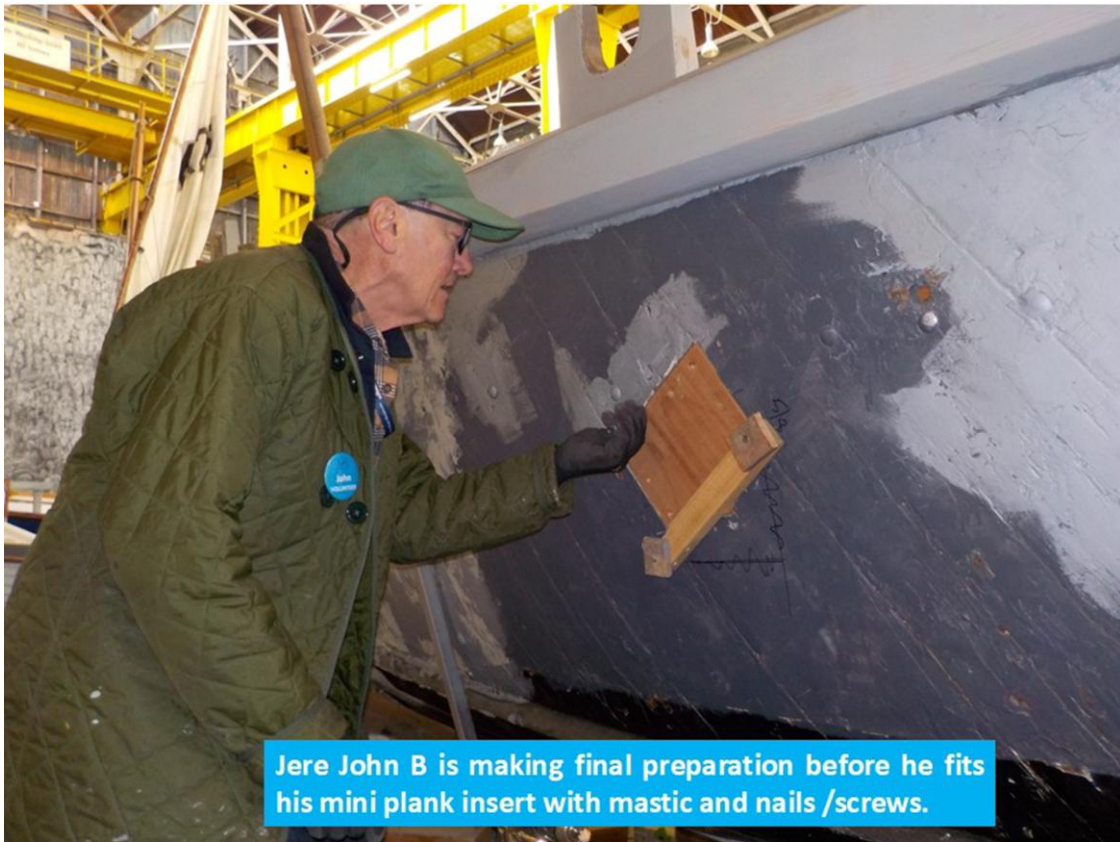
Jere John B is making final preparation before he fits his mini plank insert with mastic and nails /screws.

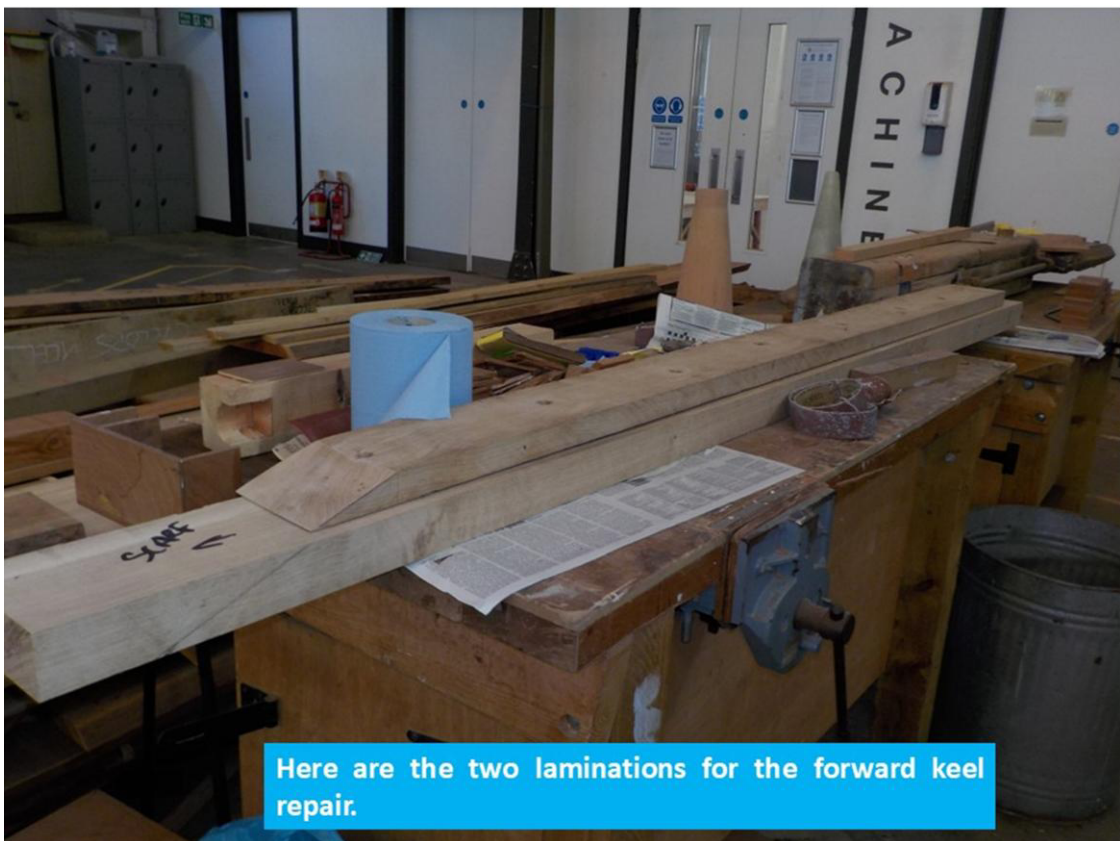
Here are the two laminations for the forward keel repair.

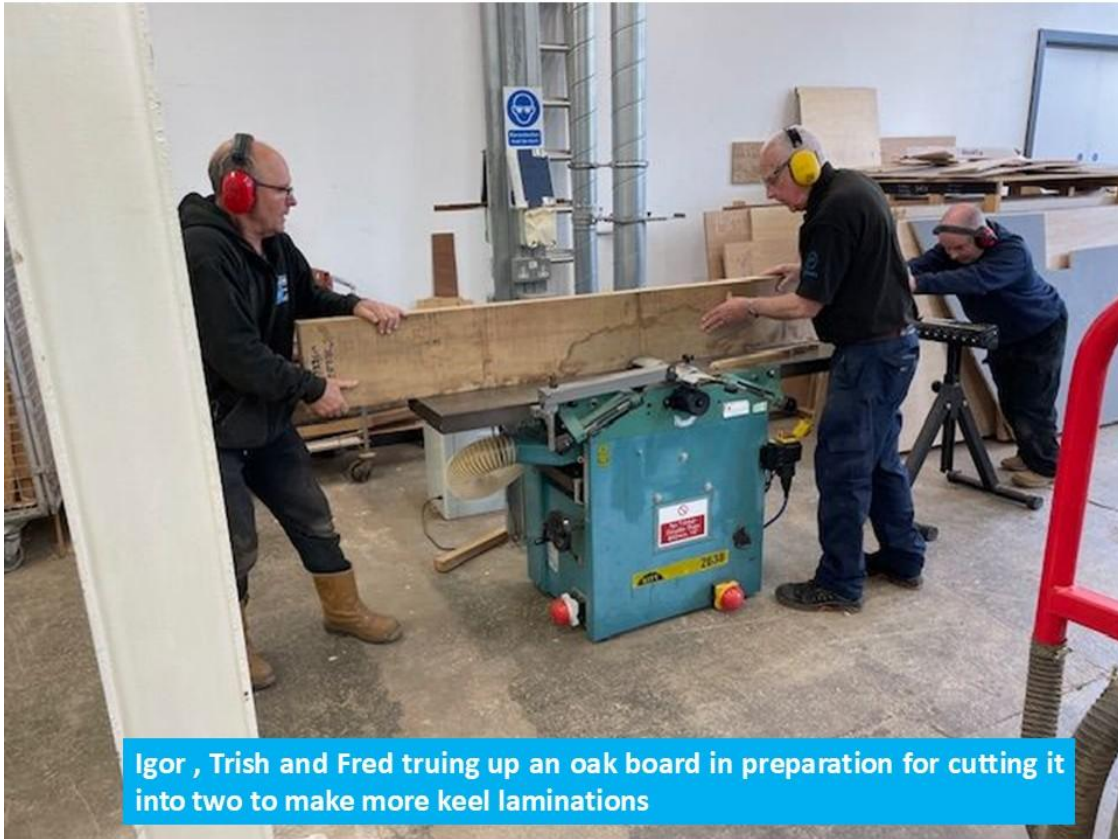
Igor , Trish and Fred truing up an oak board in preparation for cutting it into two to make more keel laminations

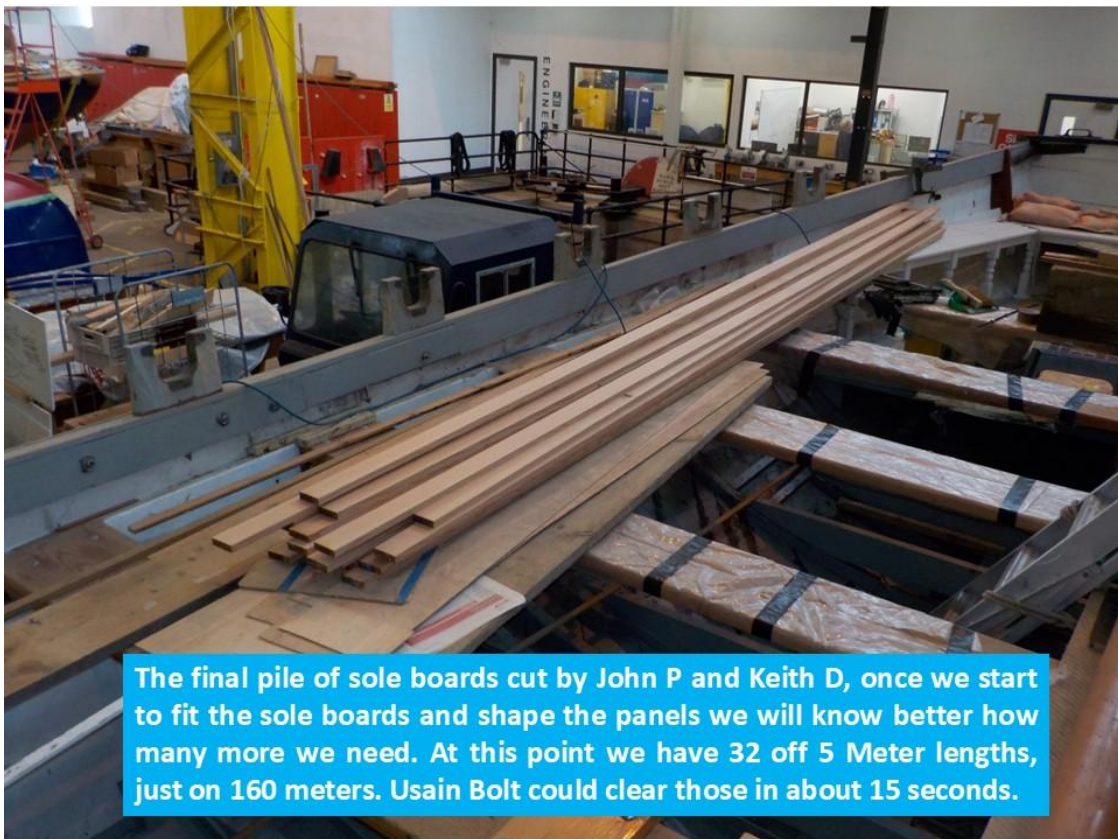
The final pile of sole boards cut by John P and Keith D, once we start to fit the sole boards and shape the panels we will know better how many more we need. At this point we have 32 off 5 Meter lengths, just on 160 meters. Usain Bolt could clear those in about 15 seconds.

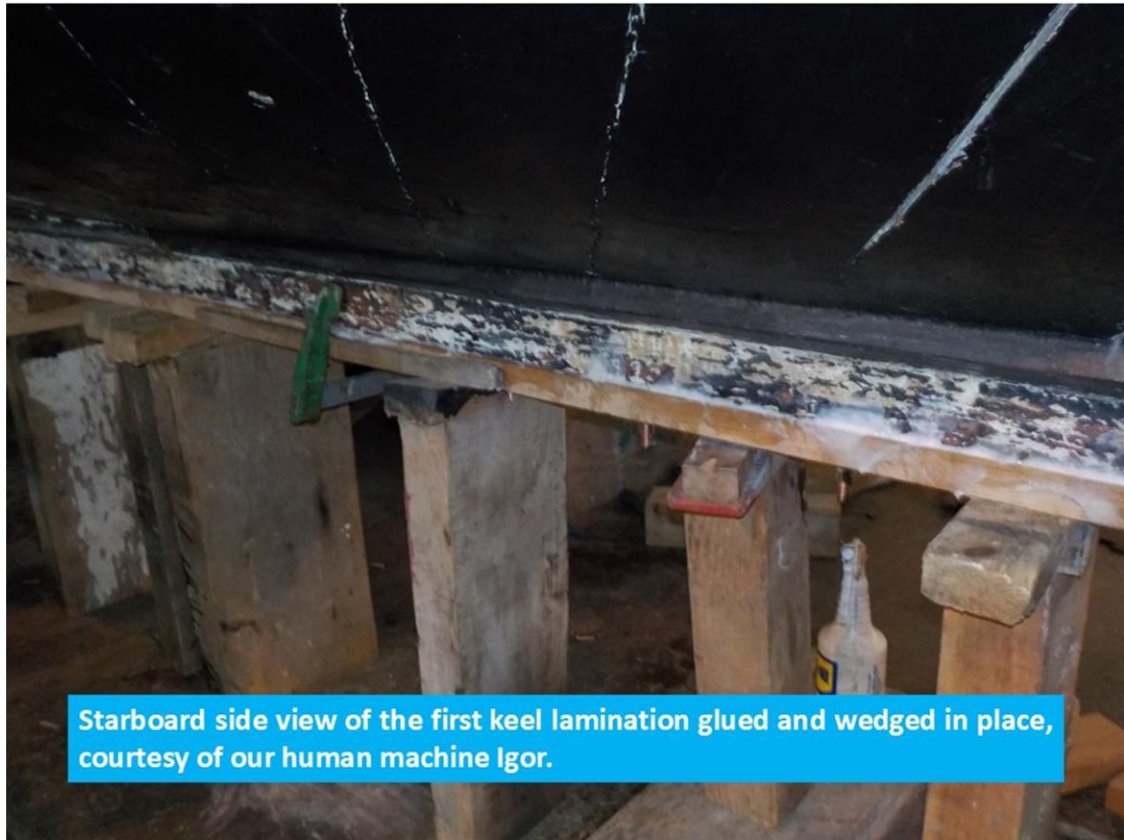
Starboard side view of the first keel lamination glued and wedged in place, courtesy of our human machine Igor.

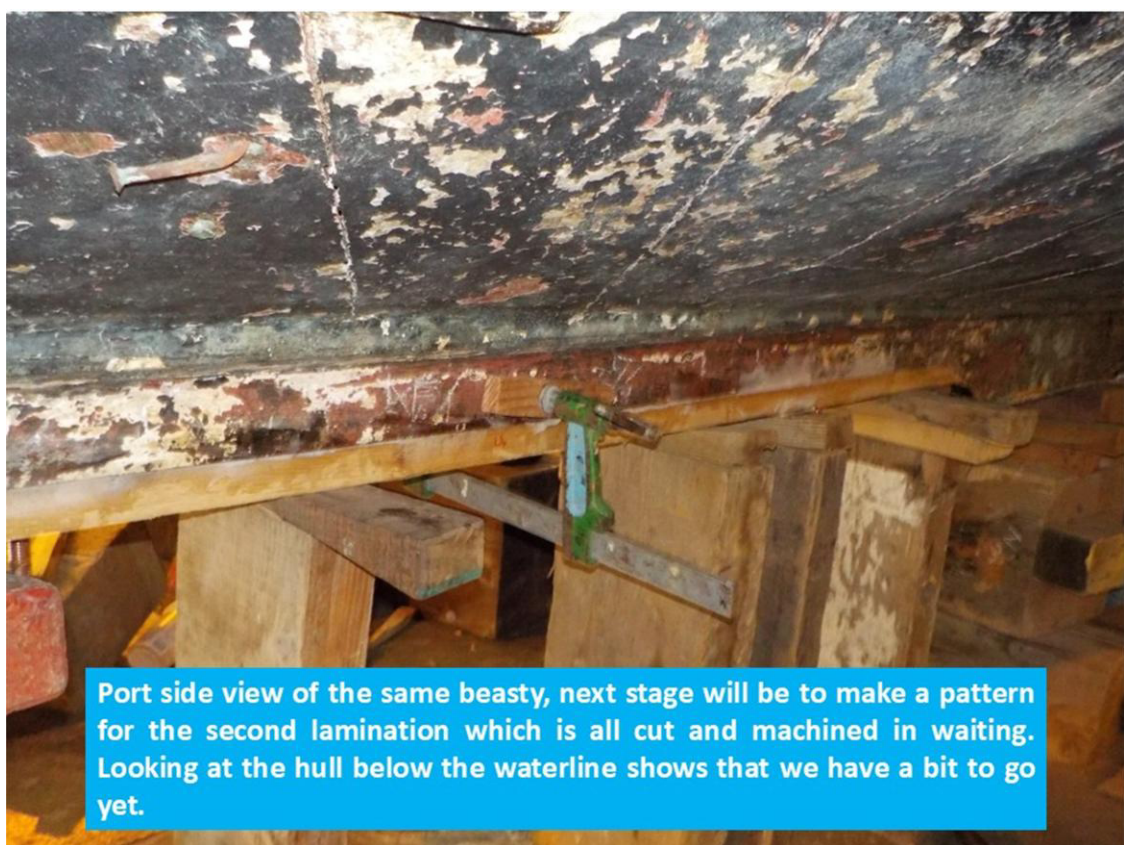
Port side view of the same beast, next stage will be to make a pattern for the second lamination which is all cut and machined in waiting. Looking at the hull below the waterline shows that we have a bit to go yet.

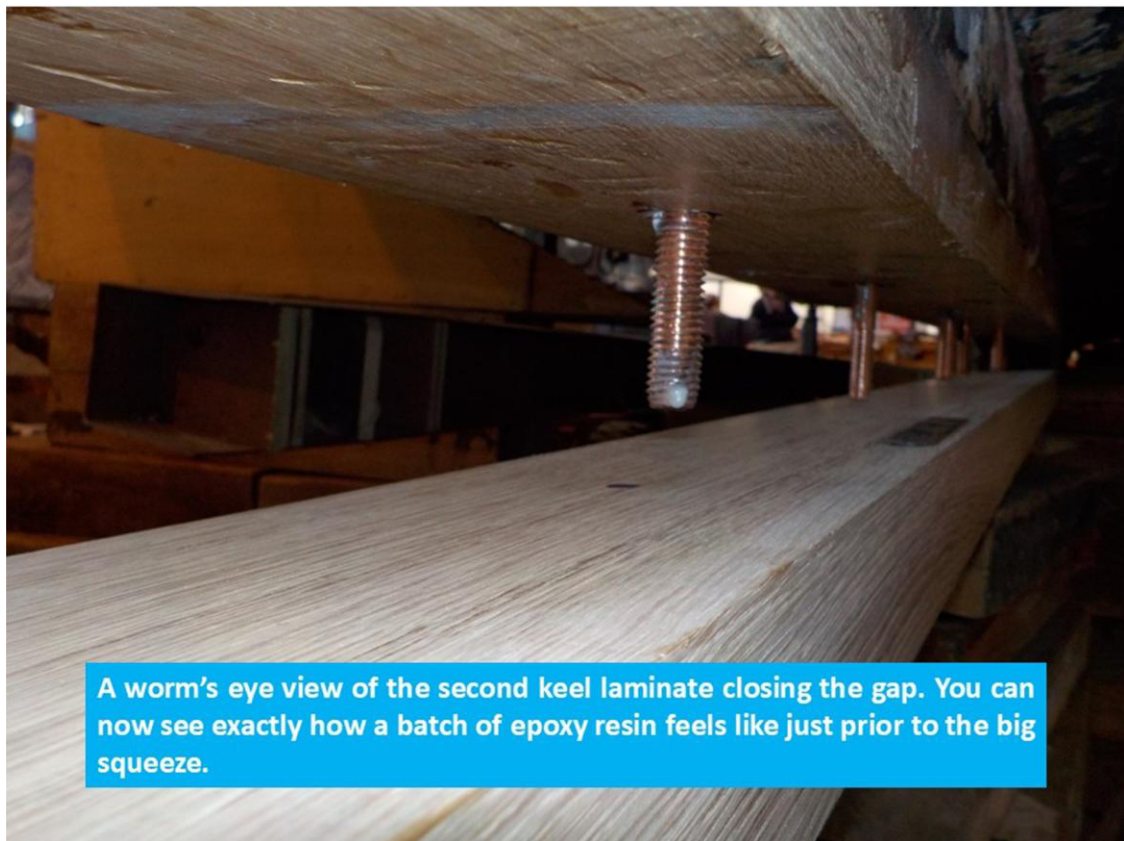
A worm's eye view of the second keel laminate closing the gap. You can now see exactly how a batch of epoxy resin feels like just prior to the big squeeze.

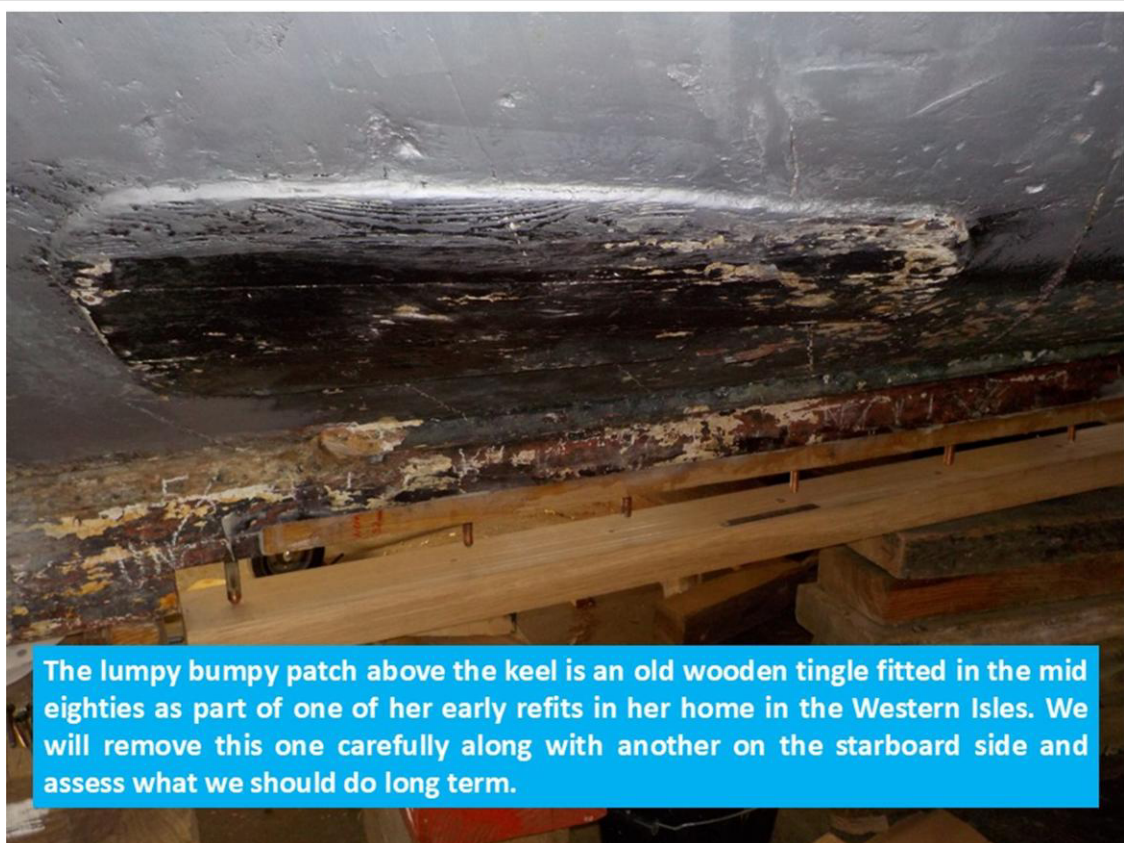
The lumpy bumpy patch above the keel is an old wooden tingle fitted in the mid eighties as part of one of her early refits in her home in the Western Isles. We will remove this one carefully along with another on the starboard side and assess what we should do long term.

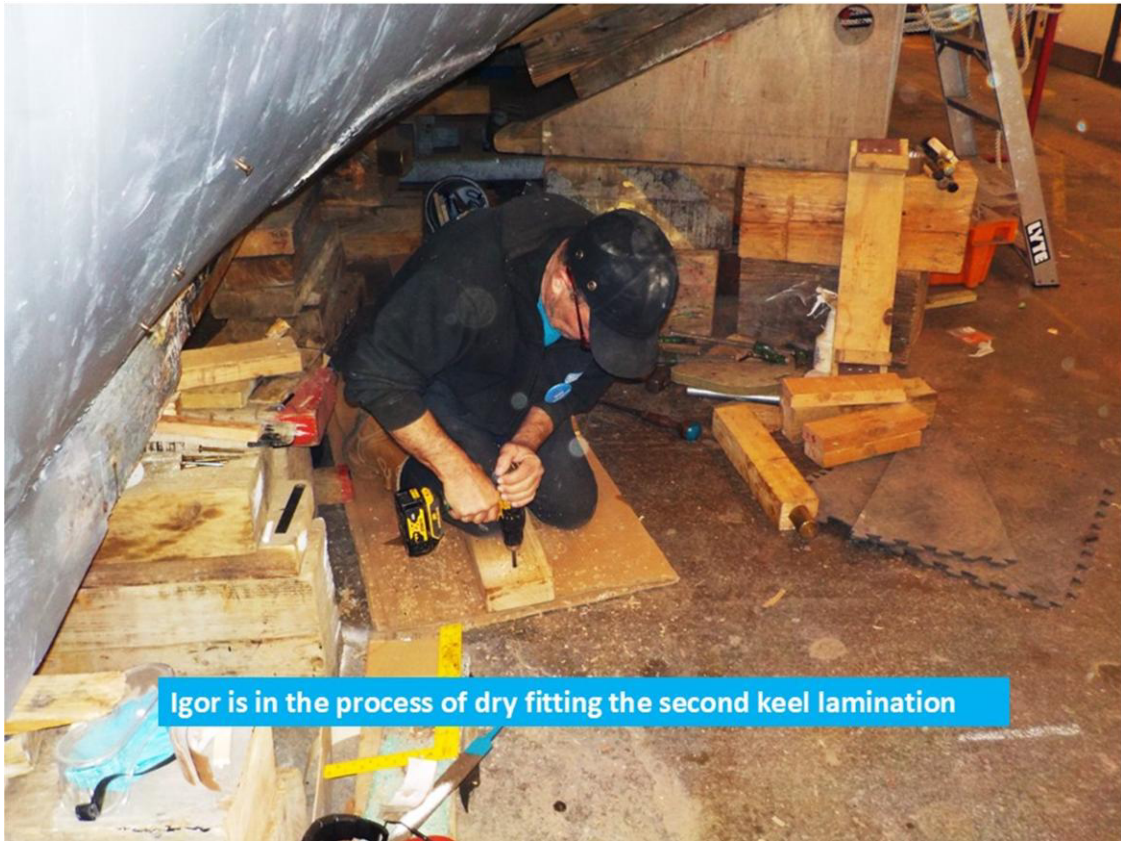
Igor is in the process of dry fitting the second keel lamination

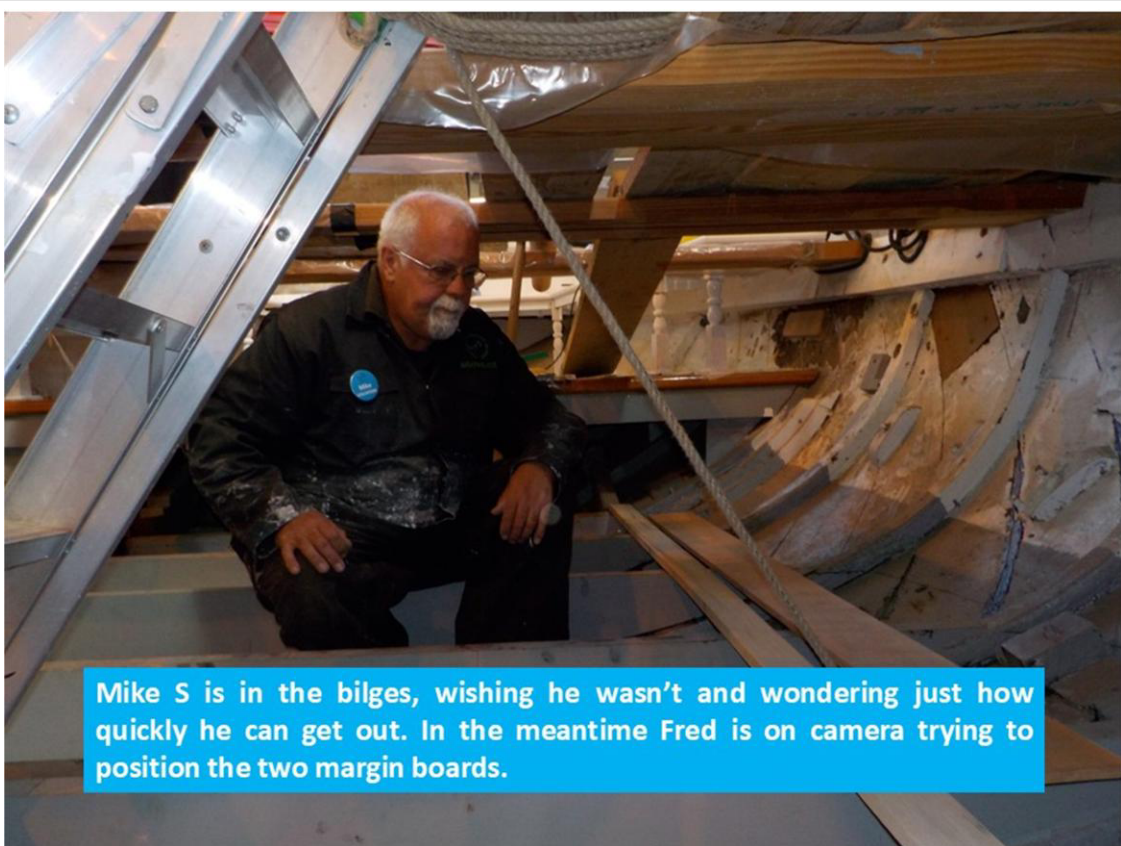
Mike S is in the bilges, wishing he wasn't and wondering just how quickly he can get out. In the meantime Fred is on camera trying to position the two margin boards.

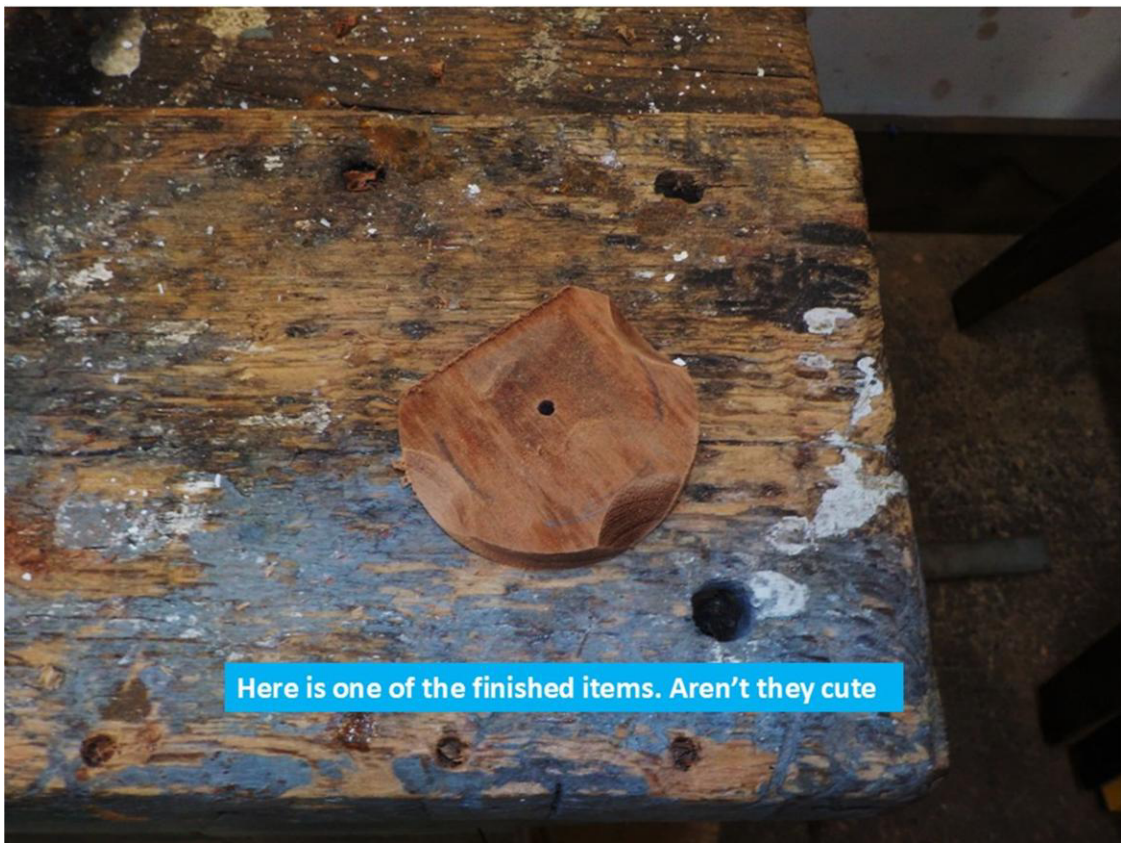
Here is one of the finished items. Aren't they cute

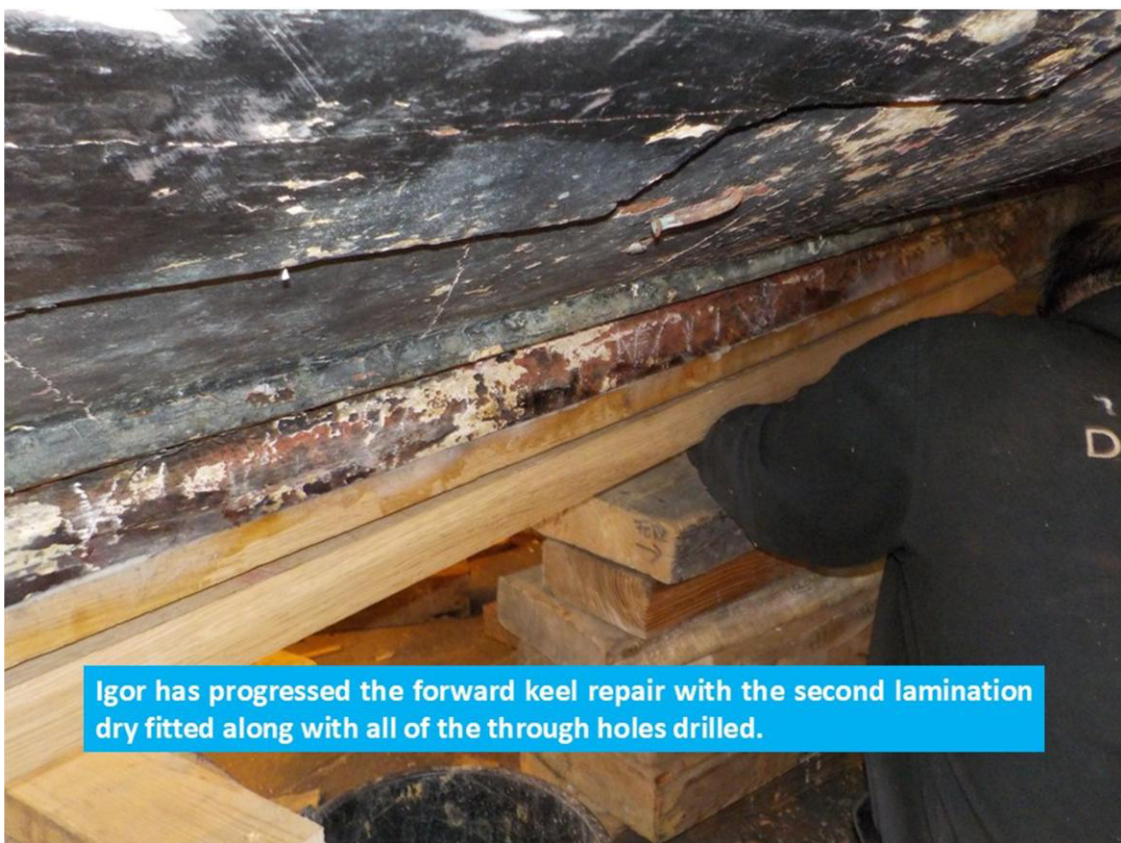
Igor has progressed the forward keel repair with the second lamination dry fitted along with all of the through holes drilled.
